Safety Analysis of Extruding W-Beam Guardrail Terminal Crashes

**Report from Joint AASHTO-FHWA Task Force on
Guardrail Terminal Crash Analysis**

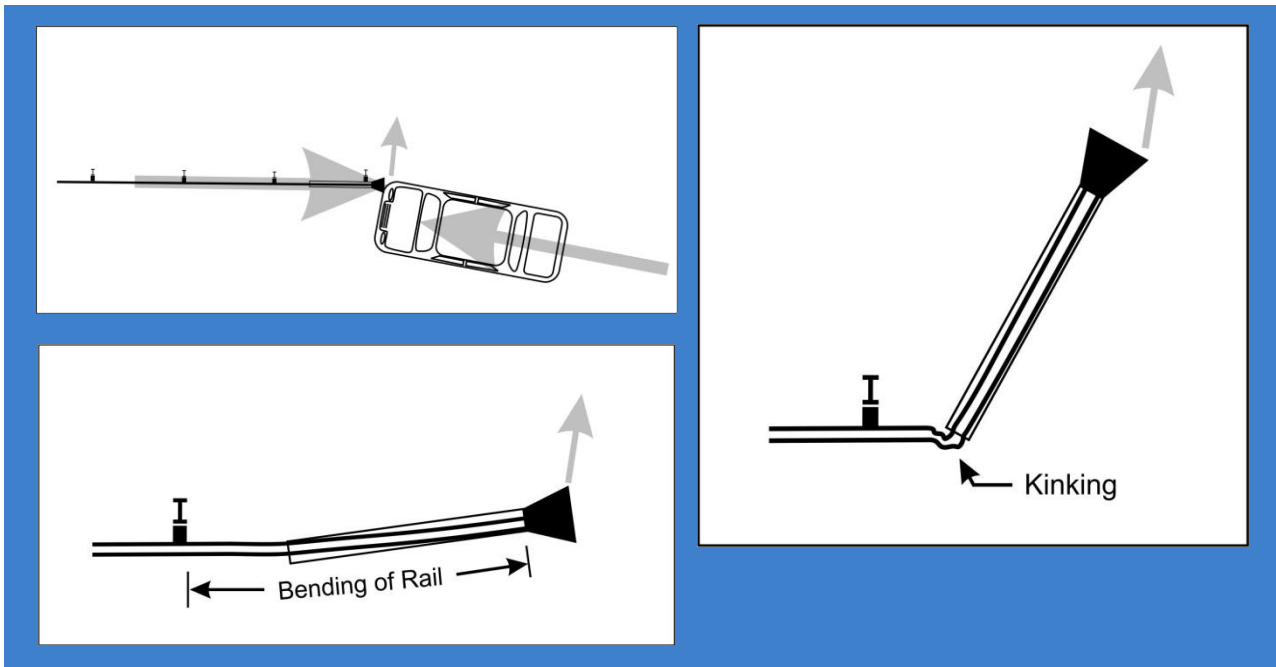
Figures 5 and 6 depict the difference between kinking of the guardrail due to bending, and kinking of the guardrail due to buckling. An angle impact at the nose of the terminal will likely push the terminal to the side, causing the system to bend, creating a kink in the rail as shown in Figure 5. Figure 6 shows a load applied at the nose of the terminal but the w-beam rail that is downstream does not have the necessary stiffness to resist bending. In either case, the terminal is no longer able to travel down the rail and absorb the energy of the crash. The vehicle may continue forward and come in contact with the kink in the rail.

Figure 5 - Example of kinking of the guardrail due to bending

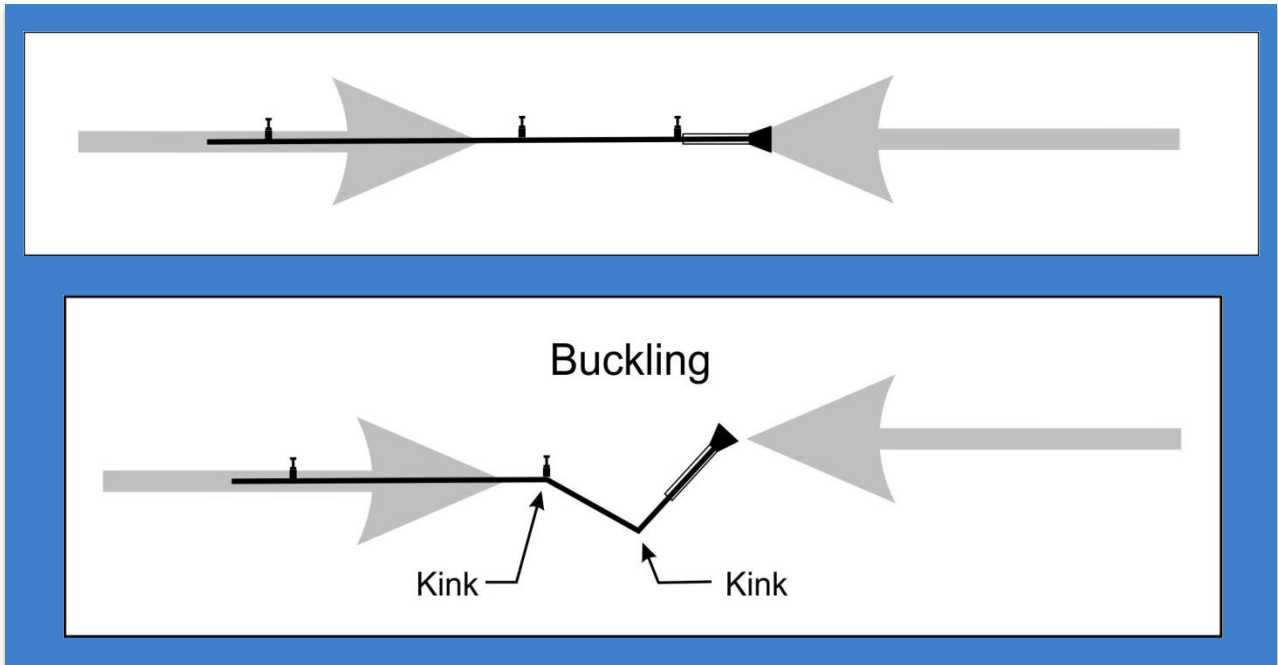
Figure 6 - Example of kinking of the guardrail due to buckling

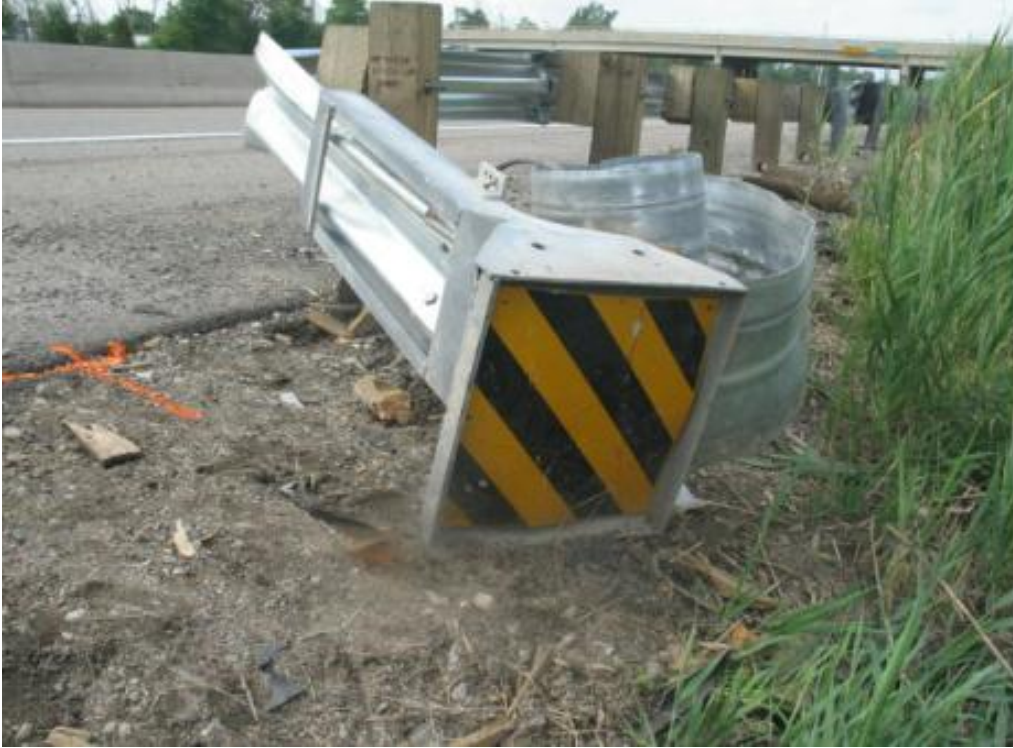
Photo 2 – Close-up of end terminal

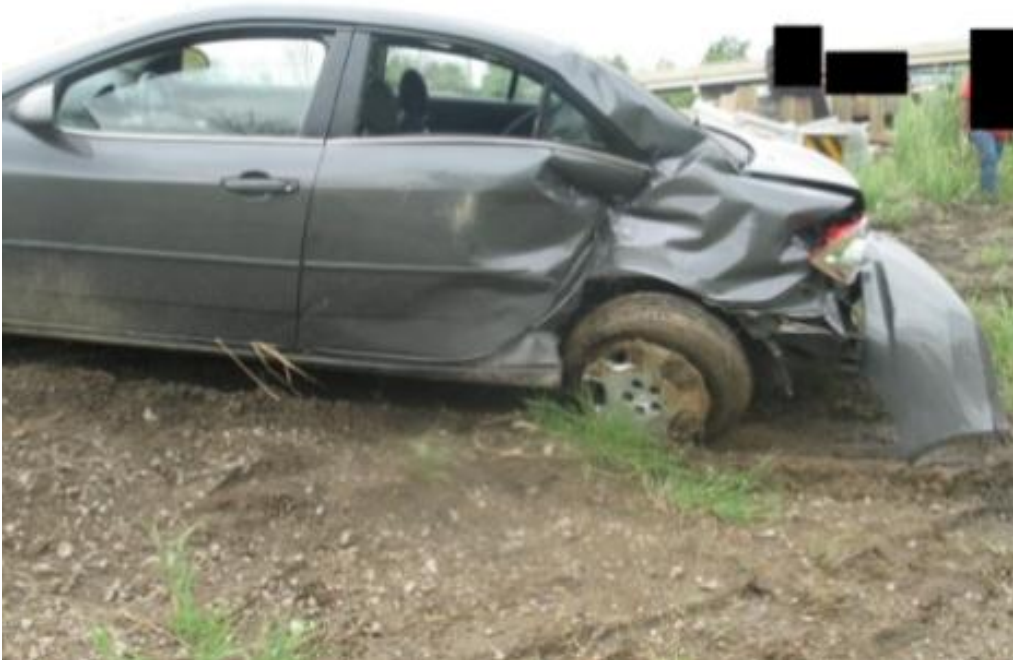
Photo 3 - Damage to vehicle

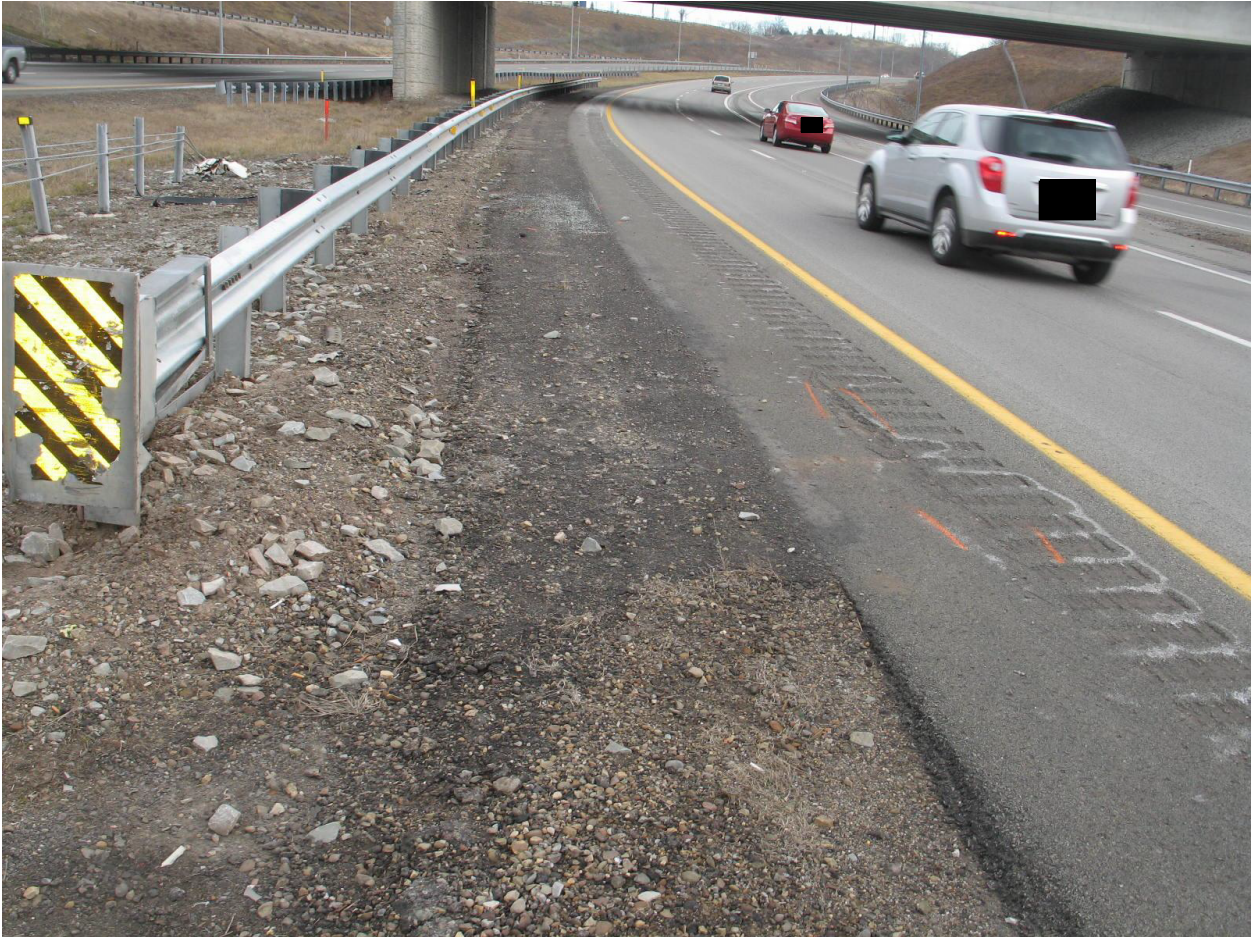
Photo 11 - Repaired terminal at crash site

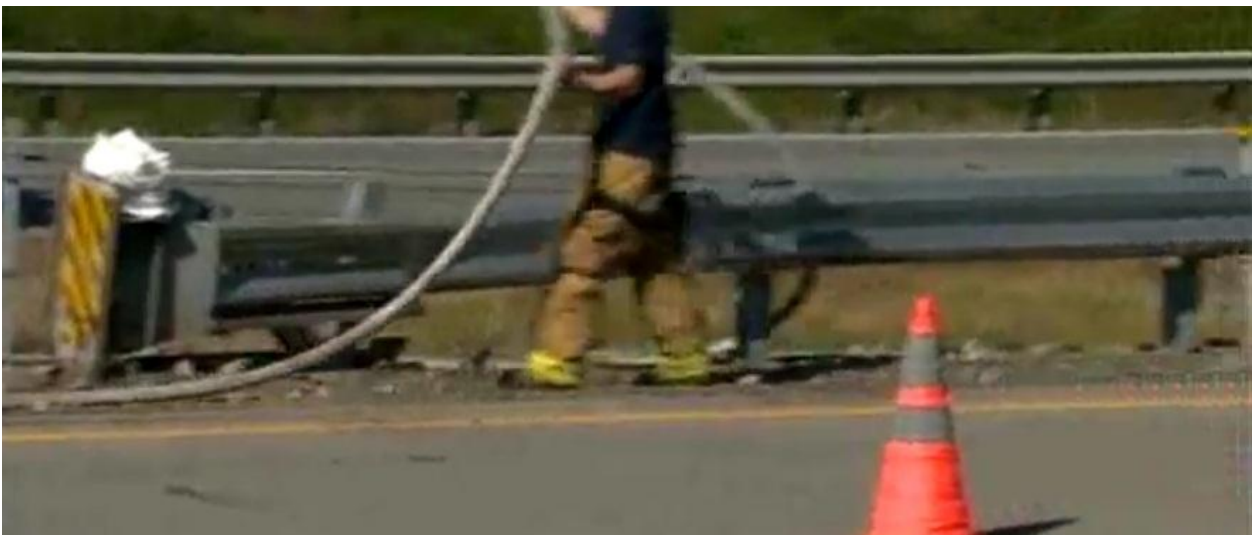
Photo 12 - On-scene photo of terminal after impact

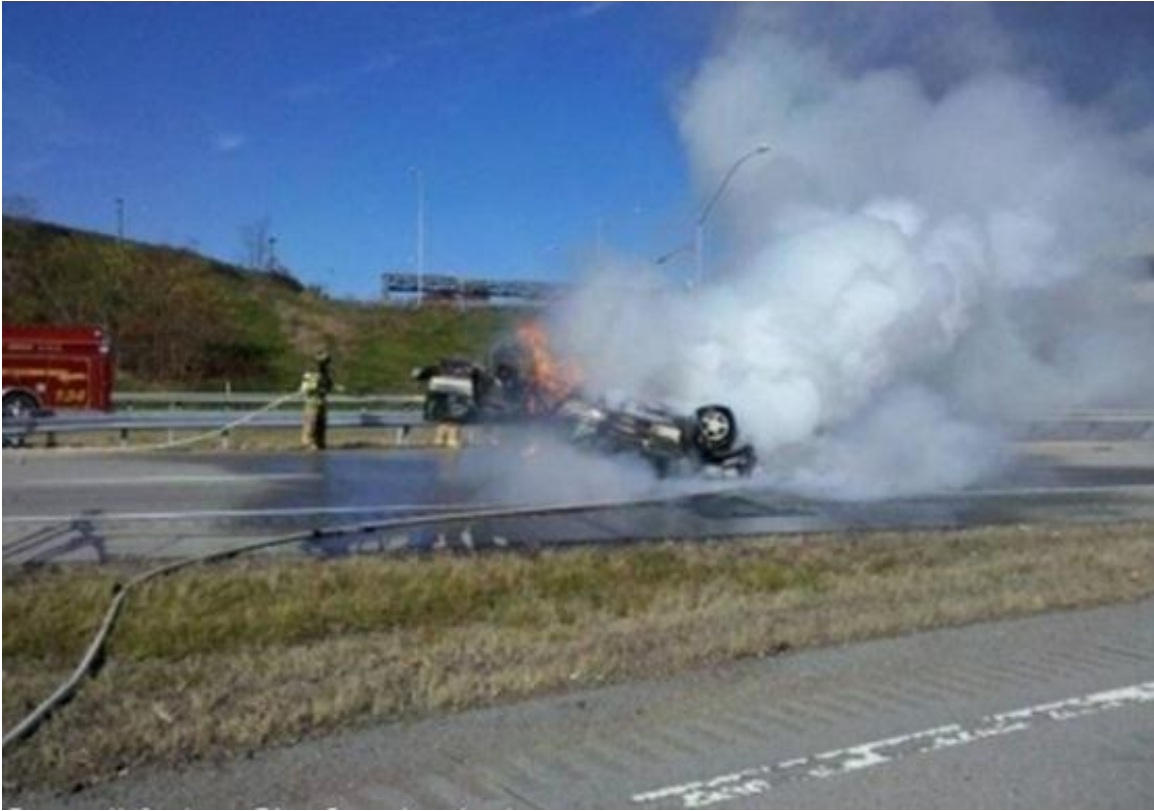
Photo 13 - Crash scene after impact and vehicle roll

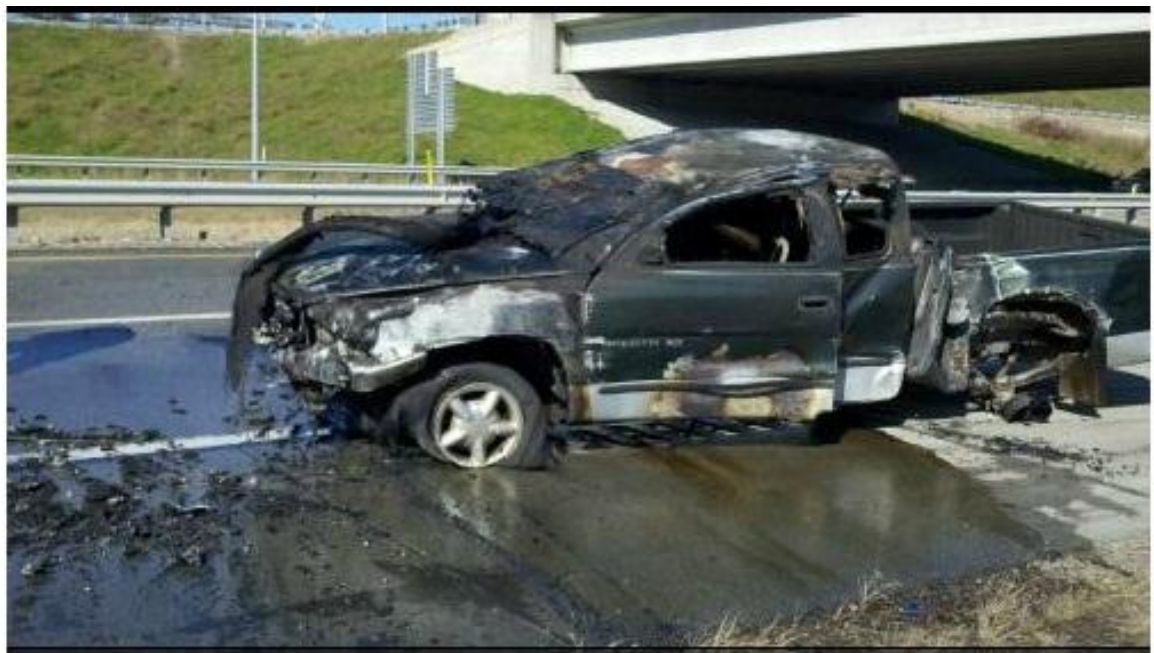
Photo 14 - Damage near the left rear tire, the initial point of contact with

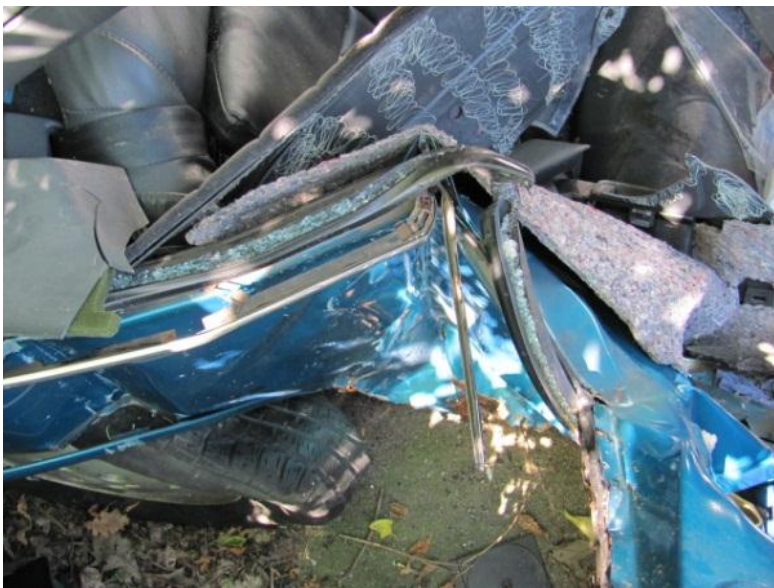
Photo 16 – Point of end terminal contact

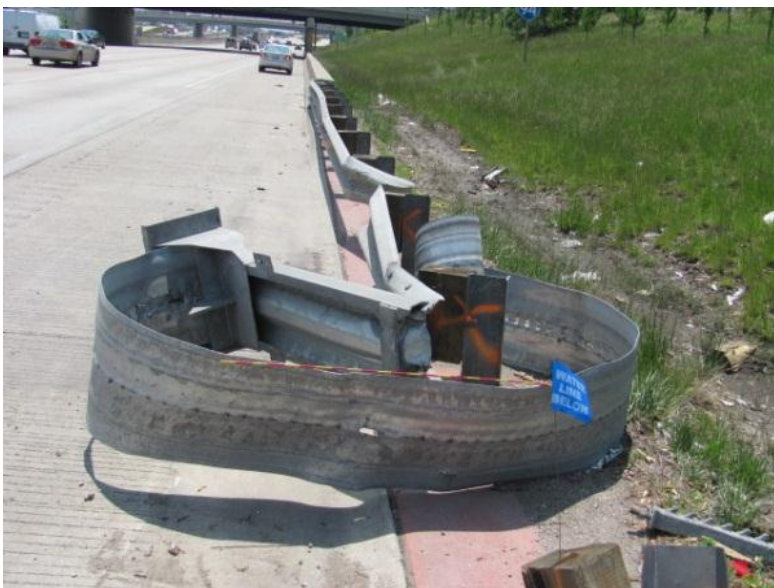
Photo 17 – Post-impact rail condition

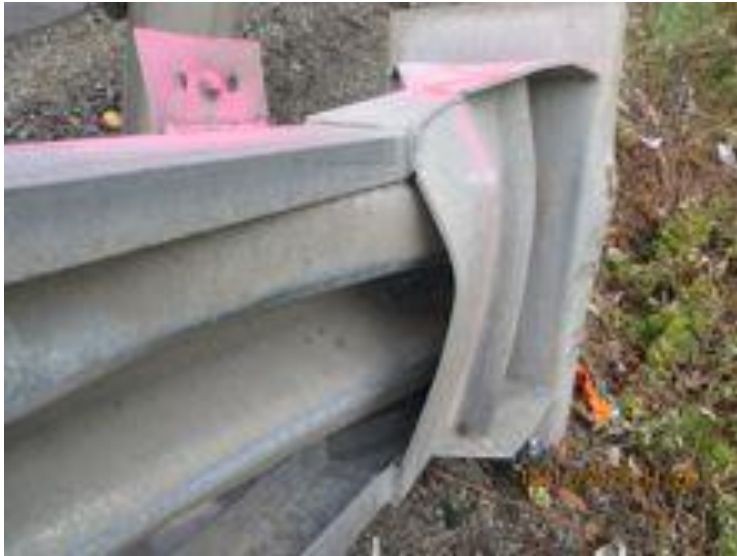
Photo 34- Bowing of reducer sides

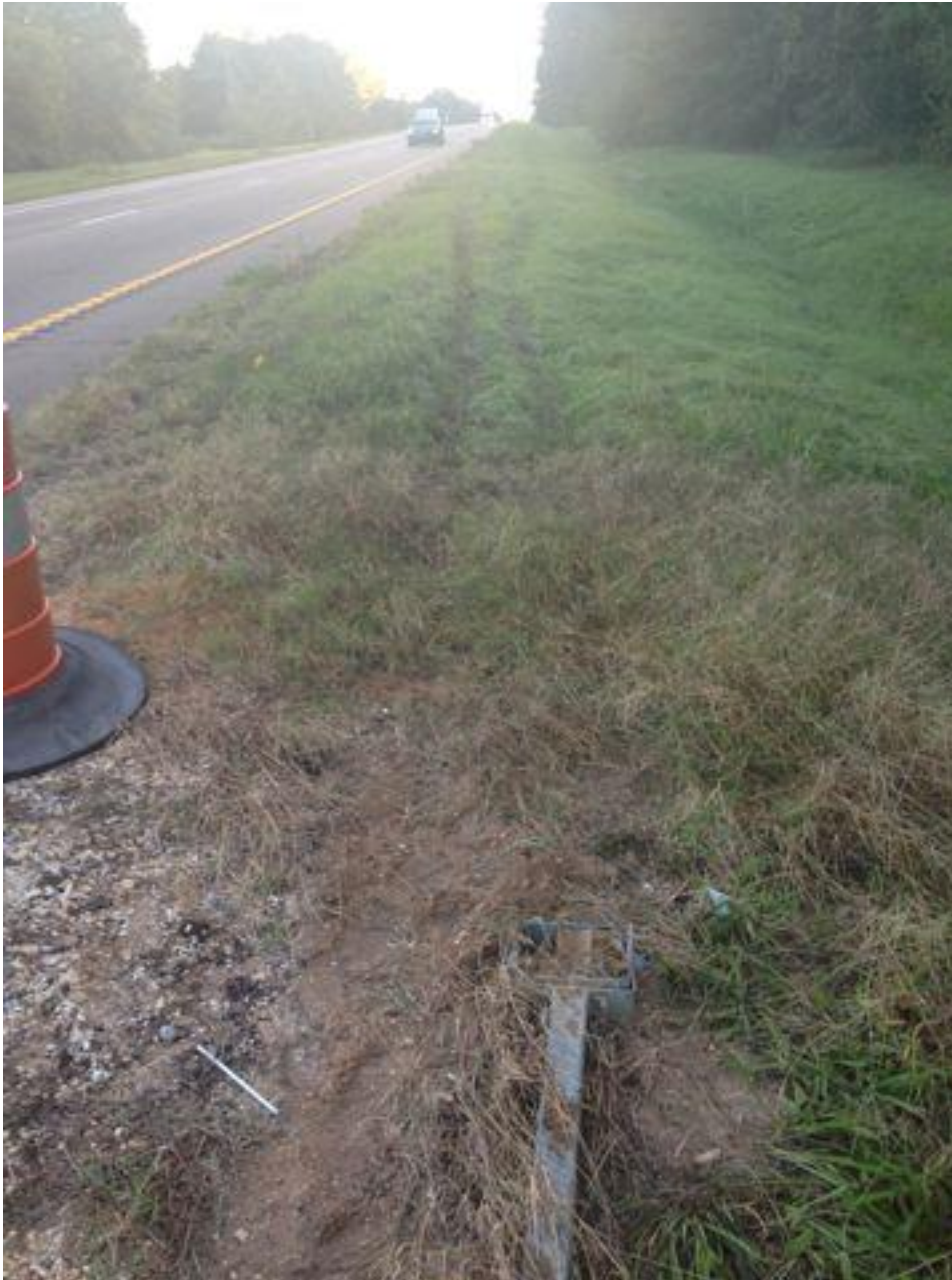
Photo 45 - Approach trajectory of vehicle

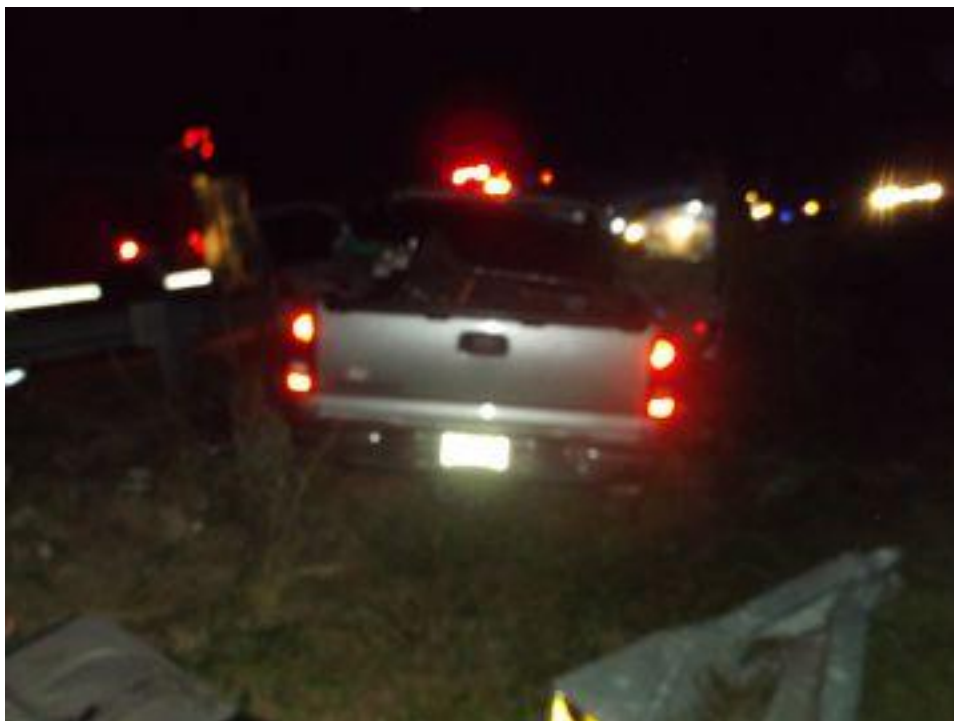
Photo 46 - Terminal and rail beyond vehicle point of rest

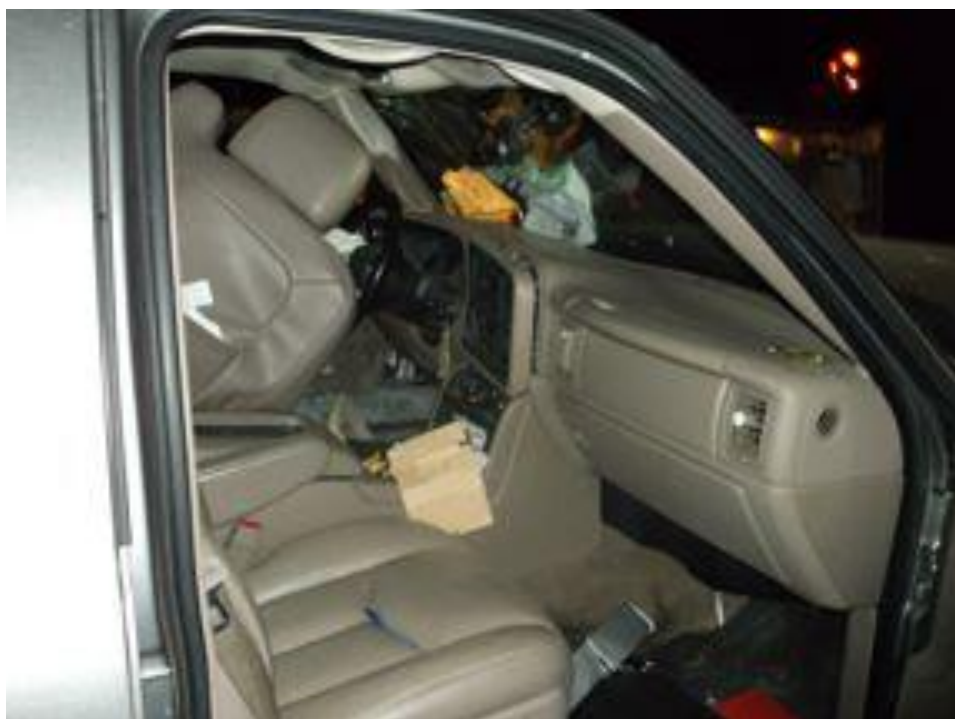
Photo 47 - Rail visible in driver's side footwell

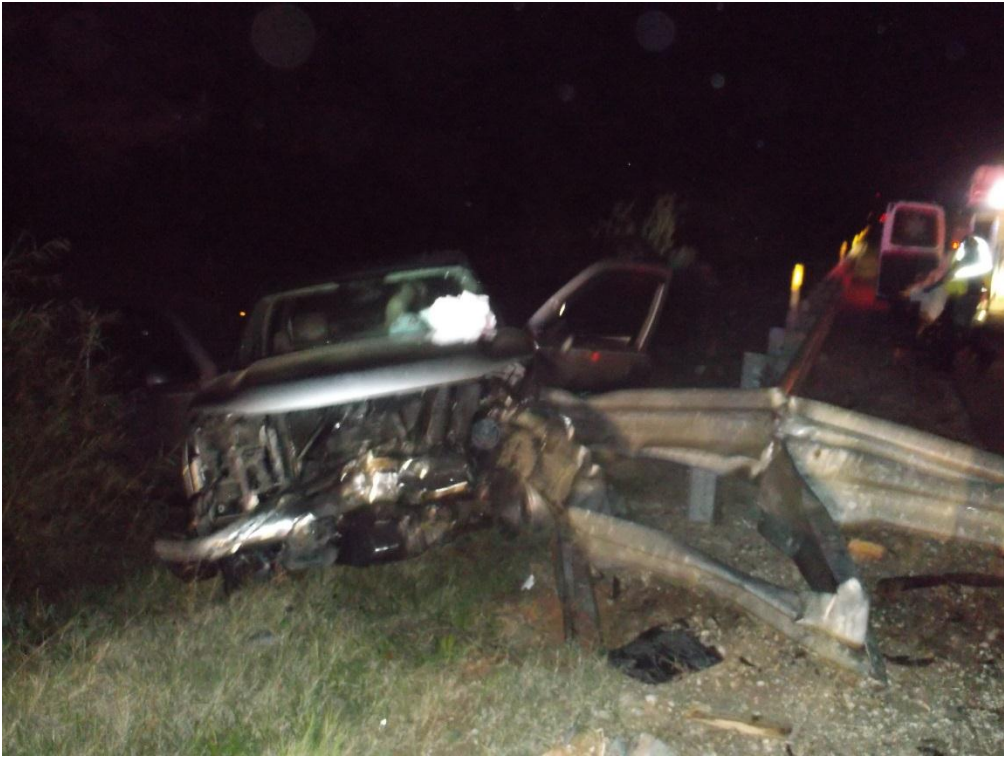
Photo 48 - Final rest of vehicle

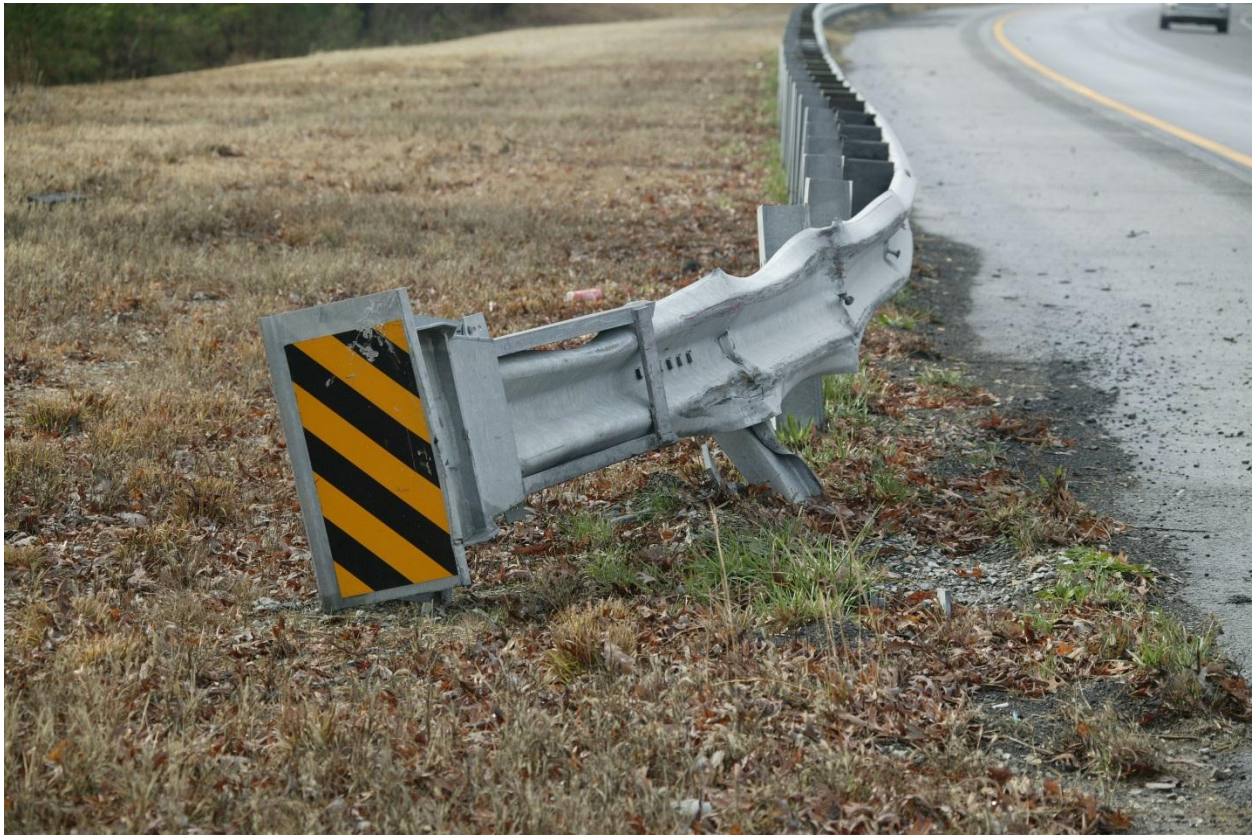
Phase: 2A
Case # 93

This case consisted of 43 photographs of a damaged guardrail system. There was no information on the driver, the vehicle, or severity of crash. This case was not forwarded to the Task Force.

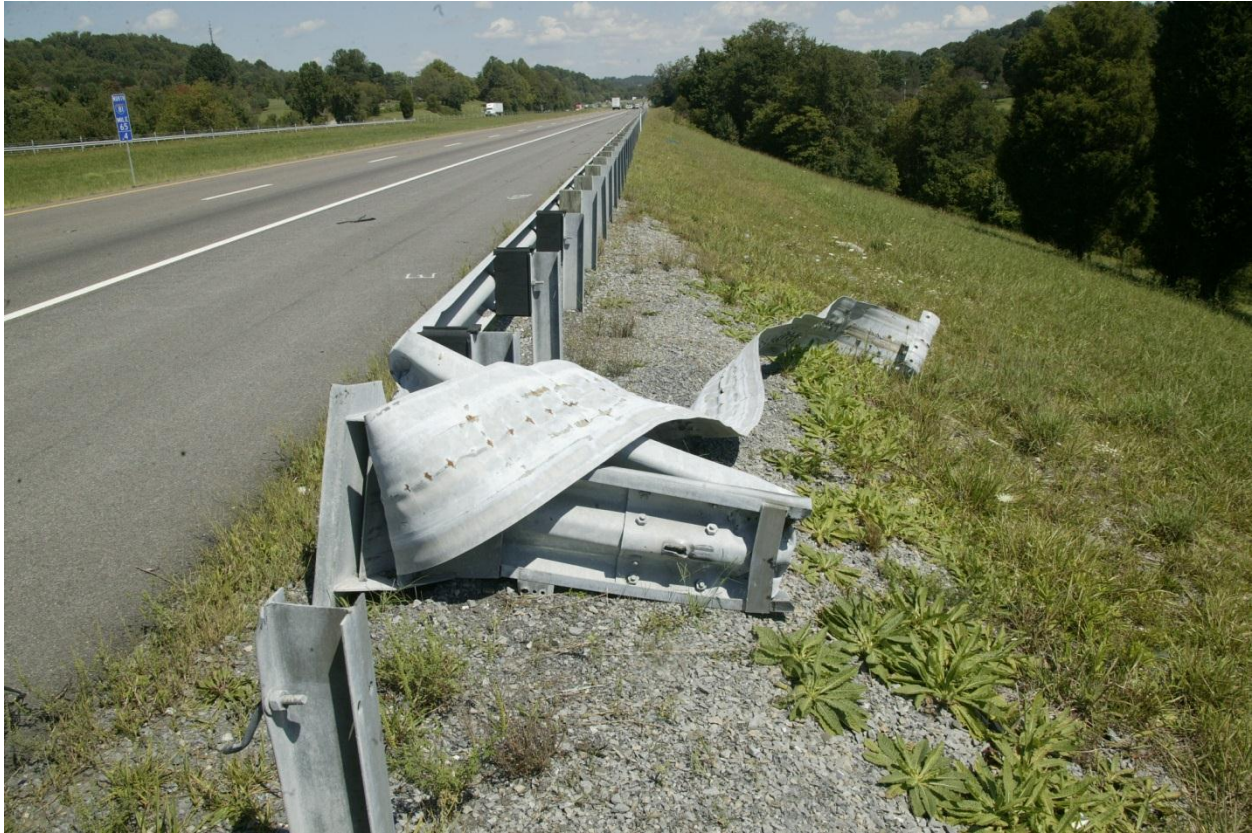
Phase: 2A
Case # 125

This case consisted of 27 photographs of a damaged guardrail system. There was no information on the driver, the vehicle, or the severity of the crash. This case was not forwarded to the Task Force.

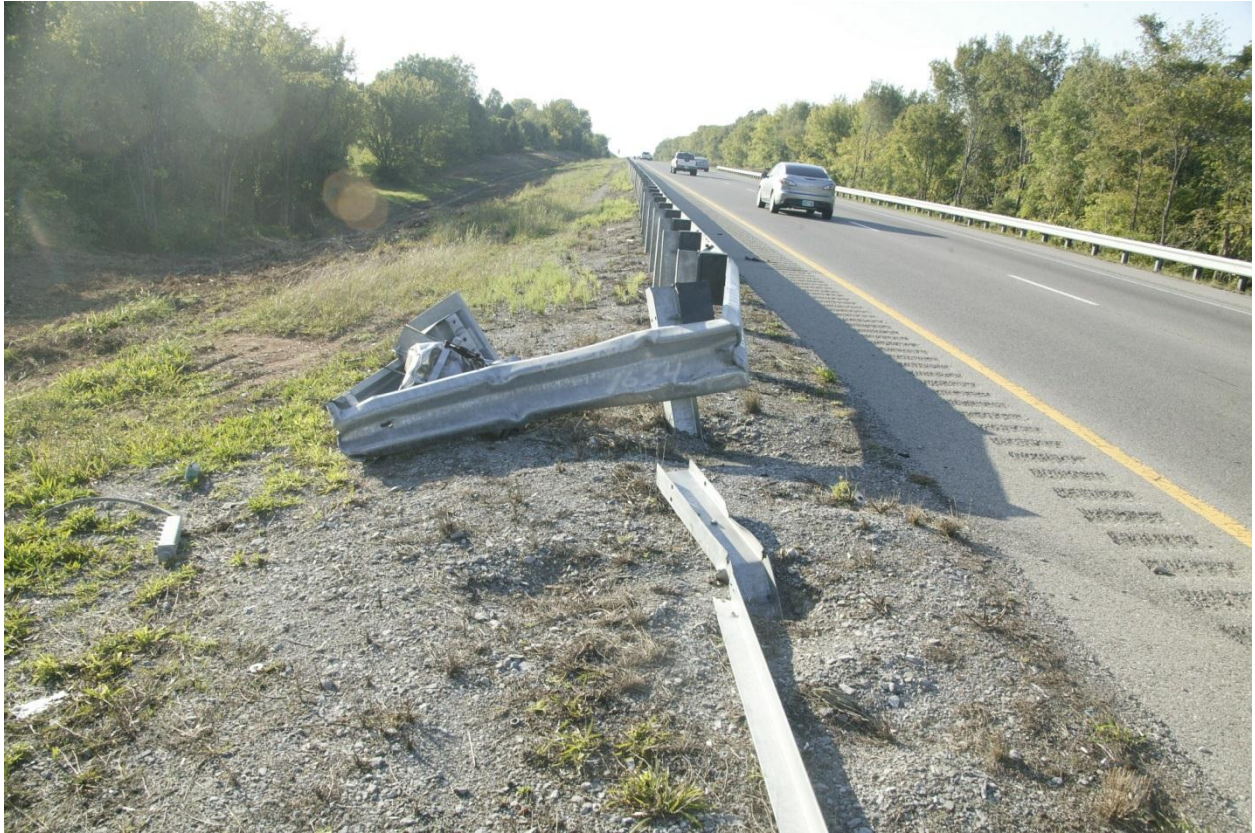
Phase: 2A
Case # 68

This case consisted of 22 photographs of a damaged guardrail system. There was no information on the driver, the vehicle, or the severity of the crash. This case was not forwarded to the Task Force.
