Safety Analysis of Extruding W-Beam Guardrail Terminal Crashes

**Report from Joint AASHTO-FHWA Task Force on
Guardrail Terminal Crash Analysis**

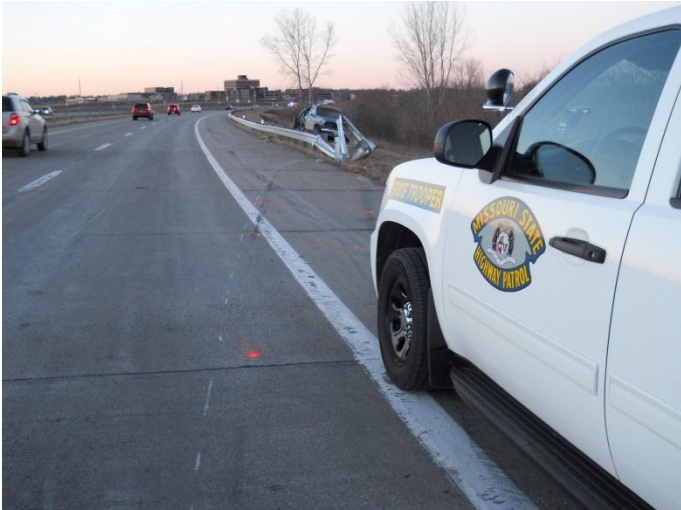
Photo 4

The available evidence indicates this impact caused the subject vehicle to lose control, initiating a clockwise rotation and sending it skidding toward the right side of the roadway, as evidenced by the skid marks shown in Photo 4. The vehicle had rotated nearly one-quarter turn by the time it exited the paved portion of the roadway, where it impacted a 4-inch ET-Plus terminal. The vehicle made first contact with the terminal in the area of the driver's side front tire. This contact with the leading edge of the terminal left vertical indentations in the fender just above the tire, as shown in Photo 5.

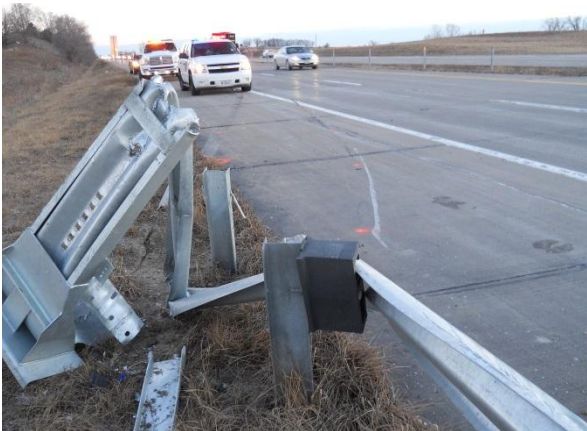
Photo 6

Approximately two feet of rail was extruded through the impact head before the angle of the impact bent the rail at the inlet chute, causing a kink to form as shown in Photo 6. This kink contacted the vehicle in the driver's door, crushing the door inward as shown in Photo 7, and initiating a roll. The vehicle rolled over one complete rotation, ejecting the two unbelted occupants. The driver sustained a fatal injury and the passenger sustained an incapacitating injury as a result of the crash.

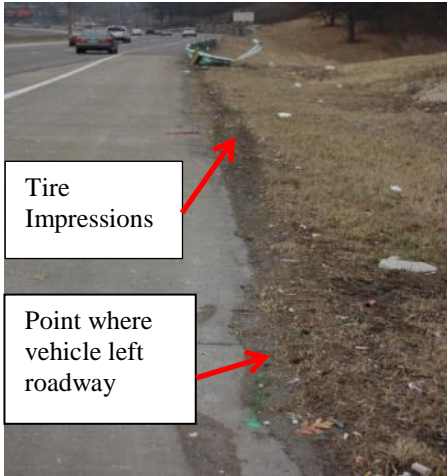
Photo 8

Based on the tire impressions shown in Photos 8 and 9, the available evidence indicates the vehicle appeared to have been heading back toward the roadway at a shallow angle just prior to impact. The initial impact with the inside edge of the terminal head occurred near the handle on the right side front door, just slightly in front of the B-pillar as shown in Photo 10. After impacting the right front door, the vehicle remained in contact with the terminal head, the right rear door was torn away from its hinges and the door was pushed rearward, exposing the rear occupant's compartment. After extruding approximately 8 to 10 feet of guardrail, the system bent and kinked toward the roadway, and the terminal head disengaged from the vehicle. After the photos shown below, a set of illustrations the Task Force developed is presented that depicts its interpretation of one possible scenario of the likely sequence of events in this crash.

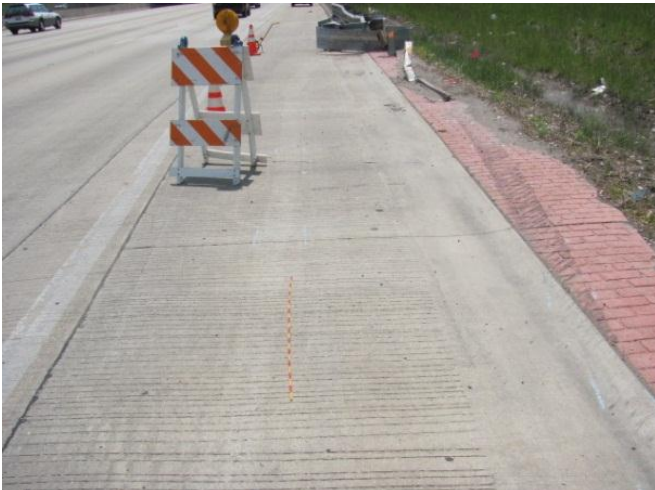
This single-vehicle crash occurred at approximately 7:00 p.m. on a May evening on a 5-lane divided roadway. The roadway was straight and level. At the time of the crash, the weather was clear and the roadway was dry. It appears there was another vehicle entering the roadway at the on-ramp and the driver of the subject vehicle, a 1993 Oldsmobile Cutlass Supreme, took evasive maneuvers to avoid a collision. The available evidence indicates the driver lost control of the vehicle and began a counterclockwise yaw. The vehicle skidded off the roadway to the right (Photo 15) and struck an ET-Plus terminal. Photo 16 indicates the impact occurred on the right side in the rear passenger door area. The force of the impact deformed the door, and the inside of the door intruded into the occupant compartment.

Photo 15 - Skid marks of vehicle at point of impact

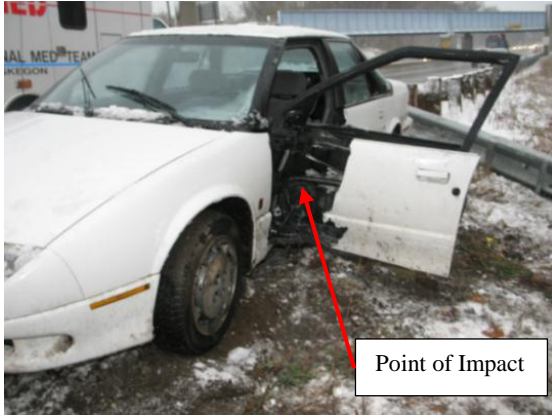
Photo 25

After impact, the vehicle rotated one-quarter turn, coming to rest facing the wrong direction. There was damage to the driver's side front door as a result of the impact (Photo 25) and minor damage to the left rear corner (Photo 26) from what appears to be additional contact with the guardrail prior to the vehicle coming to rest, as seen on the Police Report Crash Diagram. The terminal extruded a very small amount of rail and gated as the vehicle continued its rotation.

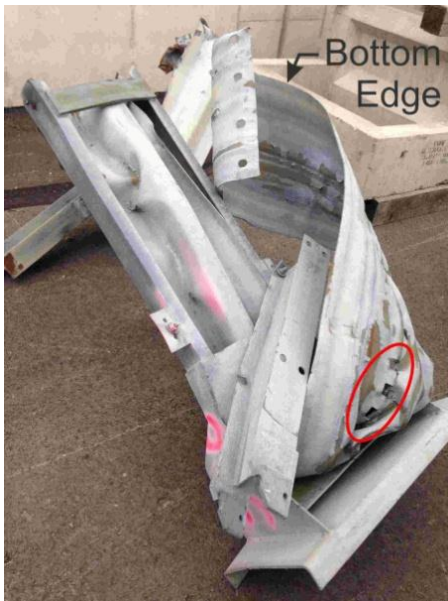
Photo 29

This was the only case the Task Force reviewed for which there appears to have been a high resistance to passage of the rail through the head of the terminal. While this behavior was likely caused by a damaged section of rail, the source and the extent of the damage could not be verified. It is possible that the rail was damaged prior to the impact event, or that it was damaged during the impact event from a vertically out-of-plane impact, as described earlier in this report.

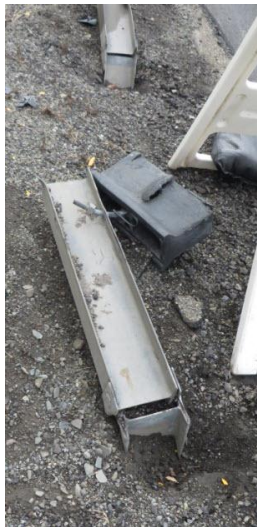
Photo 32- Post 5

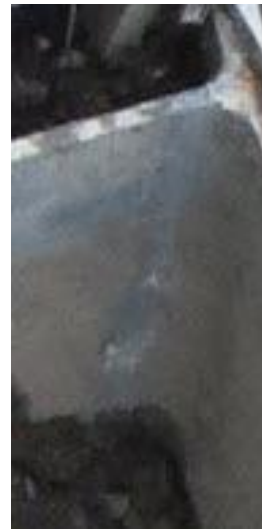
Photo 33 - Close-up of Post 5 base

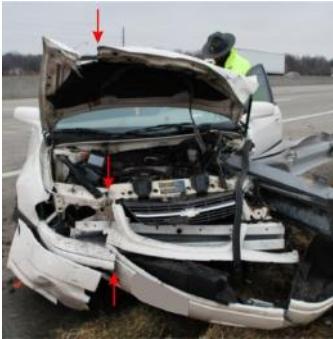
Photo 35

Damage to the hood and front of the vehicle, a 2005 Chevy Impala, indicate that the vehicle struck the left edge of an ET-Plus terminal just inboard of the right headlight (Photo 35). Due to the vehicle's relatively moderate weight and the offset nature of the impact, the vehicle began to rotate clockwise about the terminal. Based on the available evidence, it appears this rotation caused a bend to form in the rail at the inlet chute after approximately 15 feet of rail had been extruded (Photo 36). The rail kinked, and the impact head flattened across the front of the vehicle. With the loss of the extrusion process, a second kink appeared to develop downstream and contacted the vehicle just behind the left front wheel (Photo 37). This kink penetrated into the occupant compartment through the lower portion of the driver's side firewall (Photo 38).

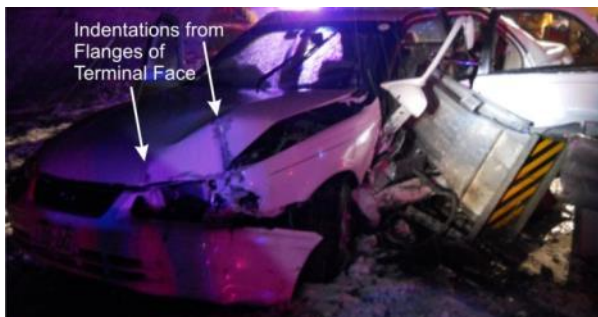
Photo 39

Upon leaving the roadway, the vehicle impacted an ET-Plus guardrail terminal with its front left corner (Photo 39). Based on the available evidence, it appears due to the rotation of the vehicle and its movement away from the road, the impact head was pushed quickly aside, bending and kinking the rail at the inlet end of the chute. The kink made contact with the vehicle near the front edge of the driver's door and penetrated into the occupant compartment (Photo 40).

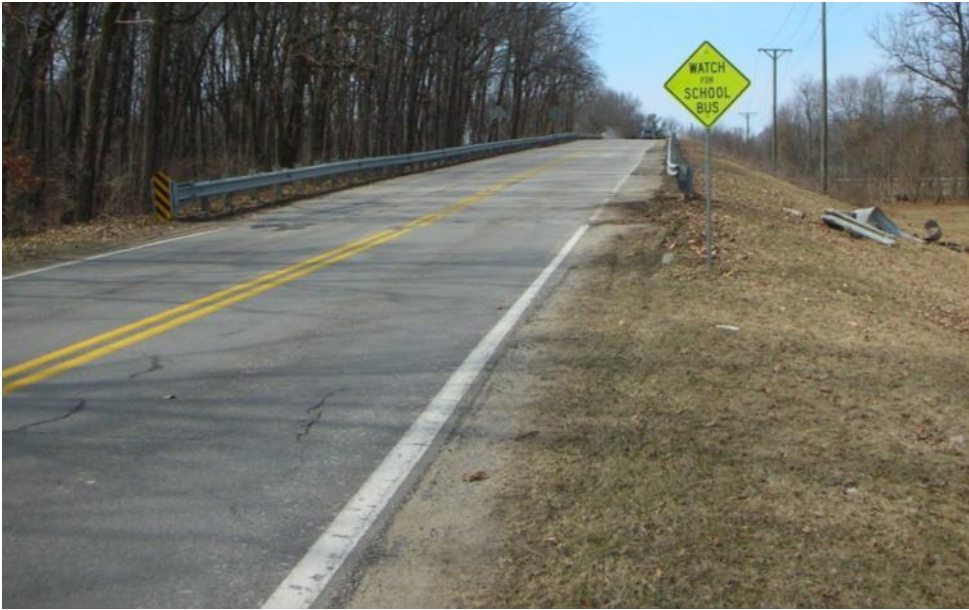
Photo 41

The subject vehicle, a 2001 Chevy Tahoe, was approaching the overpass when it departed the roadway to the right. The lack of any skid marks on the road (Photo #41) to indicate an avoidance maneuver or loss of control suggests that the driver may have fallen asleep, and the vehicle drifted off the road at a very shallow angle.

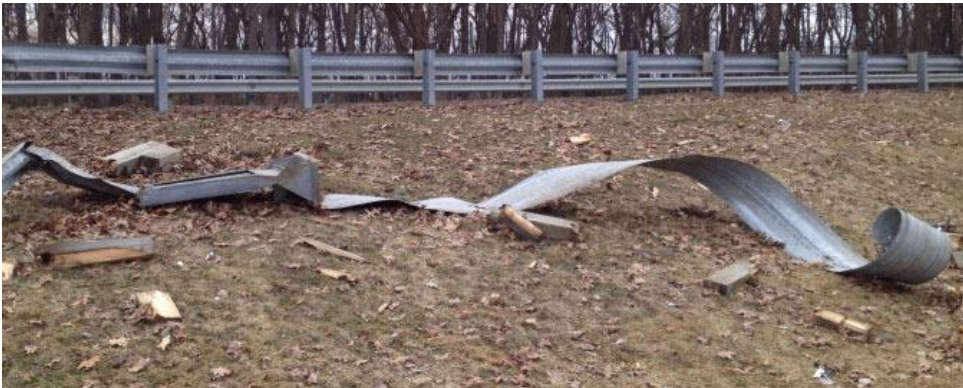
Photo 42

The vehicle impacted an ET-Plus terminal on its front right side, near the passenger-side headlight. Based on the available evidence, it appears the offset impact induced a clockwise rotation of the vehicle. Approximately 25 feet of guardrail was extruded through the impact head (Photo #42) before the rotation caused a bend to form in the rail at the entrance to the inlet chute. The rail kinked, and it appeared the impact head flattened across the front of the vehicle (Photo #43). With the loss of the extrusion process and the continued forward motion of the vehicle, kinks began to form in the guardrail downstream. At this time, the vehicle appeared to have rotated approximately one-quarter turn, one of the downstream kinks then made contact with the driver's side of the vehicle near the base of the A pillar, and penetrated into the occupant compartment (Photo #44).

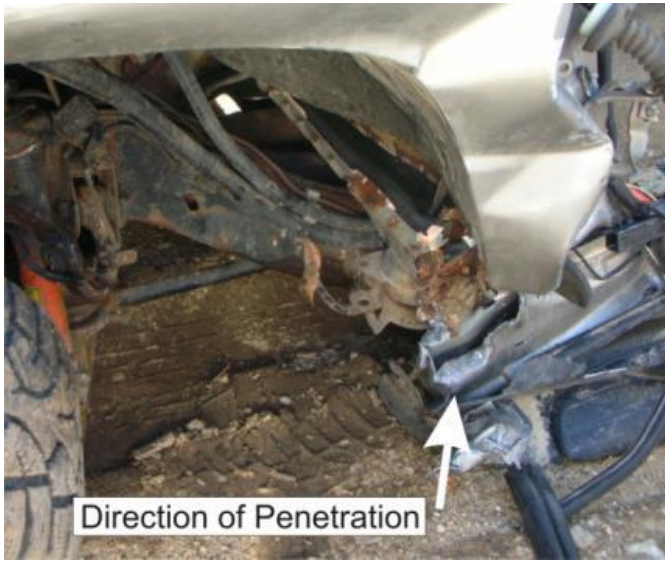
Photo 44

The potentially harmful occurrence in this case appears to be occupant compartment penetration. The conditions of this crash were beyond what would be tested under NCHRP Report 350. The subject vehicle exceeds the mass of the 2000P test vehicle by approximately 10 percent, and the offset, nearly head-on impact is not represented by any NCHRP Report 350 crash test for a vehicle of this size.

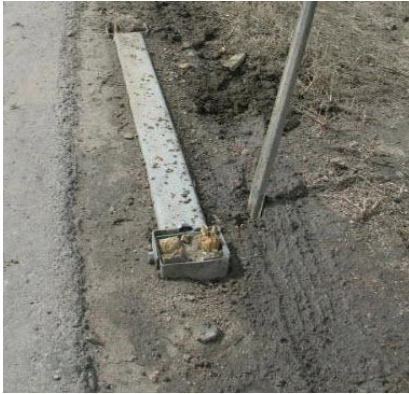
Photo 49

Based on the available evidence, it appears the tire tracks (Photo 49) indicate that the pickup was traveling nearly parallel or at a slight angle to the road at the time of impact, but had its right-side tires approximately 18 inches past the paved shoulder. That offset and the marks left by the terminal head on the front bumper (Photo 50) indicate that the likely primary contact was with the left flange of the terminal face and was approximately one foot to the right of the center of the vehicle. The photo has been marked with a solid white arrow pointing to the deep indentation made by the traffic-side flange of the terminal's face. A dashed white arrow points to the lesser indentation made by the other flange.

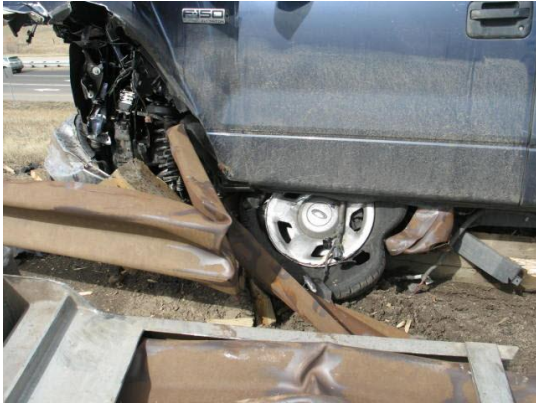
Photo 55

The slight clockwise yawing that may have occurred with the initial impact would have been counteracted by the strong final forces on the left front corner of the vehicle (Photo 55). The net result was that the pickup essentially ended up parallel to the highway (Photo 57), but four feet farther away from the shoulder than it was at initial contact.

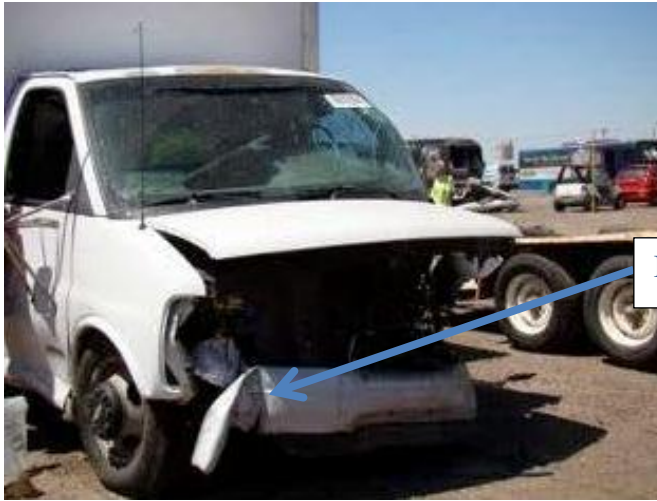
Photo 58

The subject vehicle, a 2000 Chevrolet Express Single-unit Truck, left the roadway in a tracking manner (no evidence of skid marks or tire marks found at scene) and appears to have impacted a guardrail terminal head-on. The terminal post type is unknown due to the absence of on-site crash photos. Initial contact with the terminal appears to have been made with the front passenger-side bumper (Photo 58). The terminal head extruded an unknown amount of rail before the rail kinked and the terminal head was pushed away from the vehicle.

Initial impact point

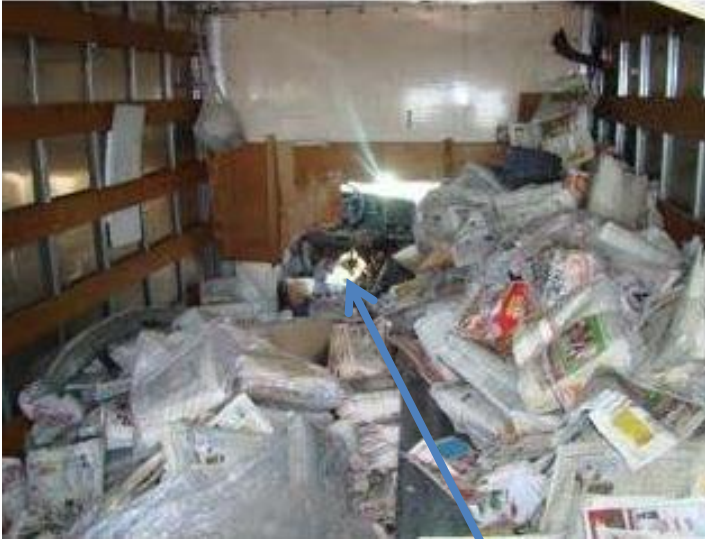
Photo 60

Based on the available evidence, it appears that several kinks formed after the initial impact and due to the mass of the vehicle (10,000-14,000 pounds), the vehicle continued down the rail with little, if any, yawing. The vehicle contacted one of the kinks in the front driver-side fender just in front of the wheel (Photo 59). The kinked rail penetrated the passenger compartment and continued through to the cargo box of the vehicle (Photo 60). At some point, the rail ruptured/separated at two separate splice joint locations (Photo 61).

Point at which the kinked rail penetrated passenger compartment

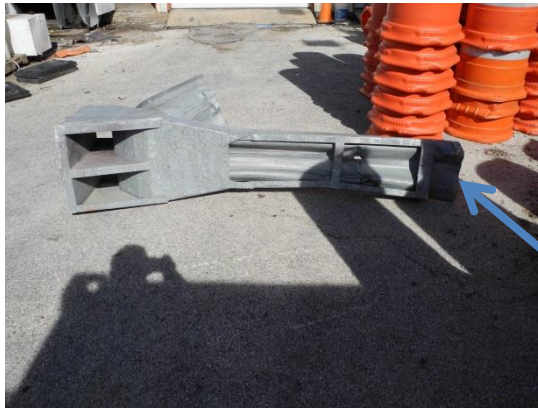
Photo 62

The potentially harmful occurrence in this case appears to be occupant compartment penetration. The conditions of this crash were beyond what would be tested under NCHRP Report 350. The assumed impact speed of 75-80 mph was significantly higher than the 62-mph speed used in crash testing. This narrative is based on limited information from the crash report and post-crash terminal photos. No photos of the vehicle or crash scene were available.

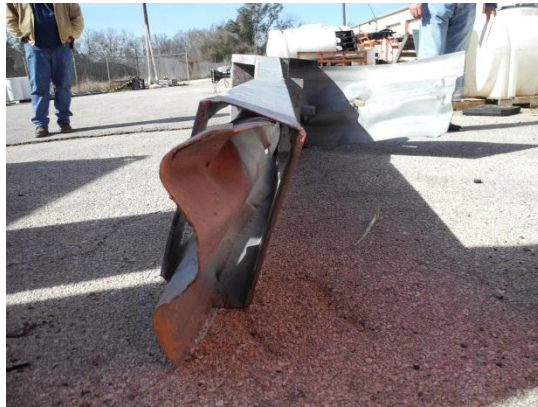
Photo 63

Cut by first responders or maintenance personnel

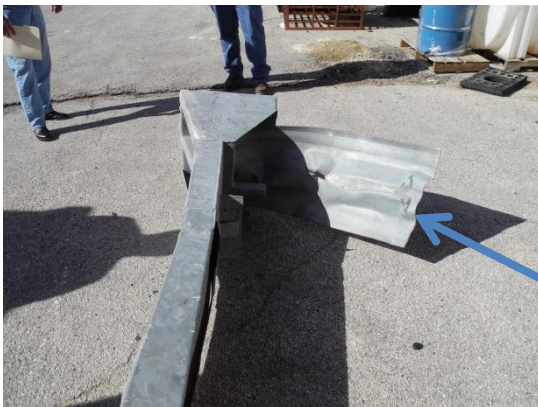
Photo 64

Cut by first responders or maintenance personnel

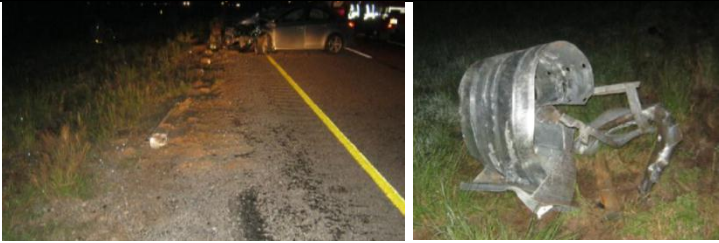
<p>Installation did not comply with the manufacturer's drawings</p>	<p>Tangent terminal installed on flare.</p>

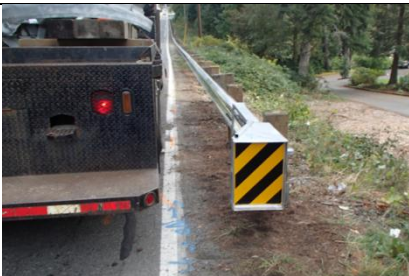
<p>Flared terminal installed on tangent.</p>

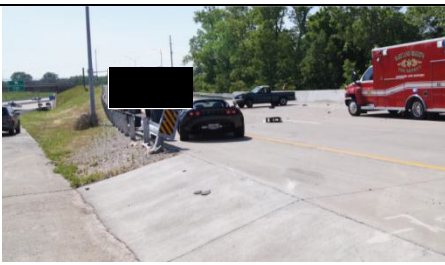
<p>Terminal placement issues</p>	<p>Within, or just beyond, sloping gore areas.</p>

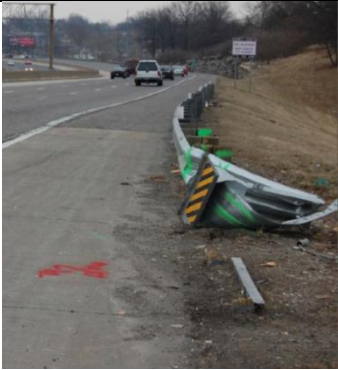
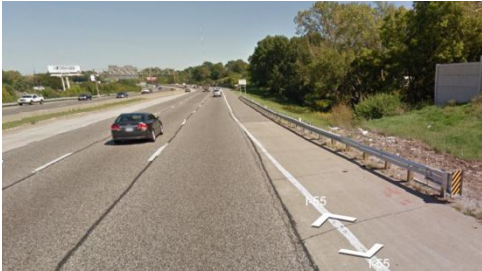
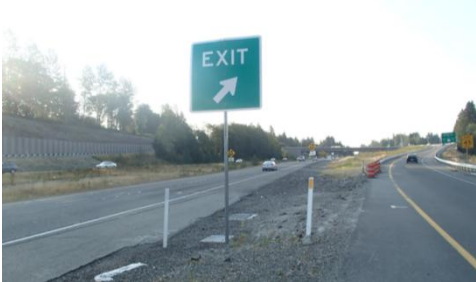
<p>Terminal placement issues</p>	<p>Where slopes behind the rail are relatively flat and free from obstacles (i.e., where a barrier may not be warranted)</p> <p><i>Barrier may present a higher level of risk than the unshielded condition.</i></p>
